NMDOT

ENVIRONMENTAL
BUREAU

2021 Lordsburg Playa Dust Storm Mitigation Update

Road Forks/Lordsburg Playa Dust Mitigation Project

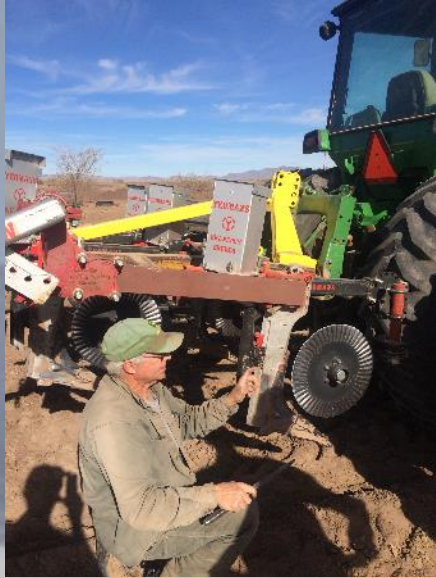
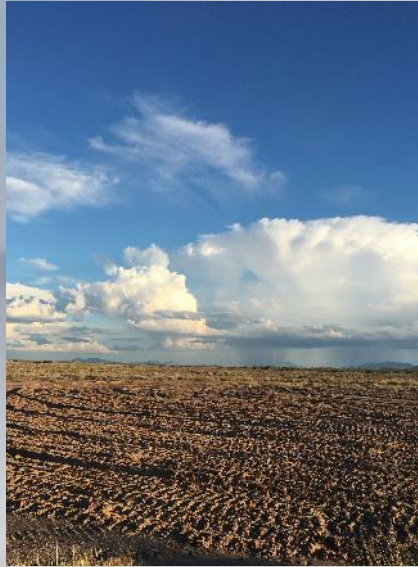
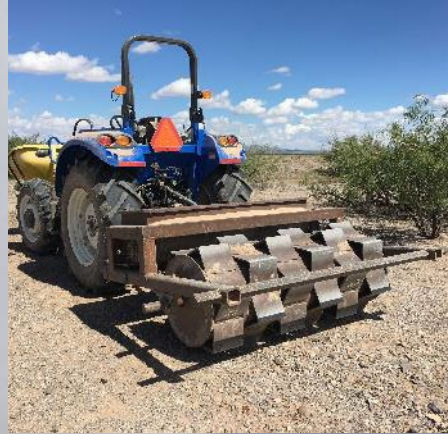
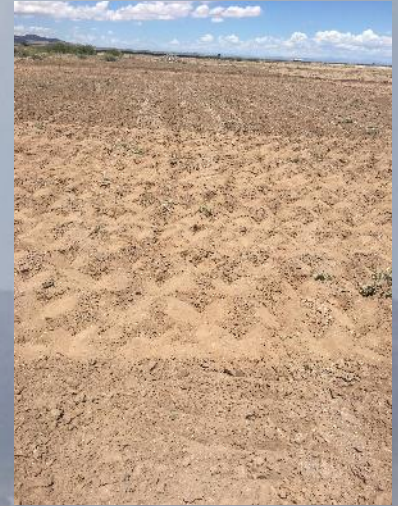
Road Forks Dust Mitigation Area

Sept. 2018: Keyline plowing, Imprinting, Tackifier , Fencing

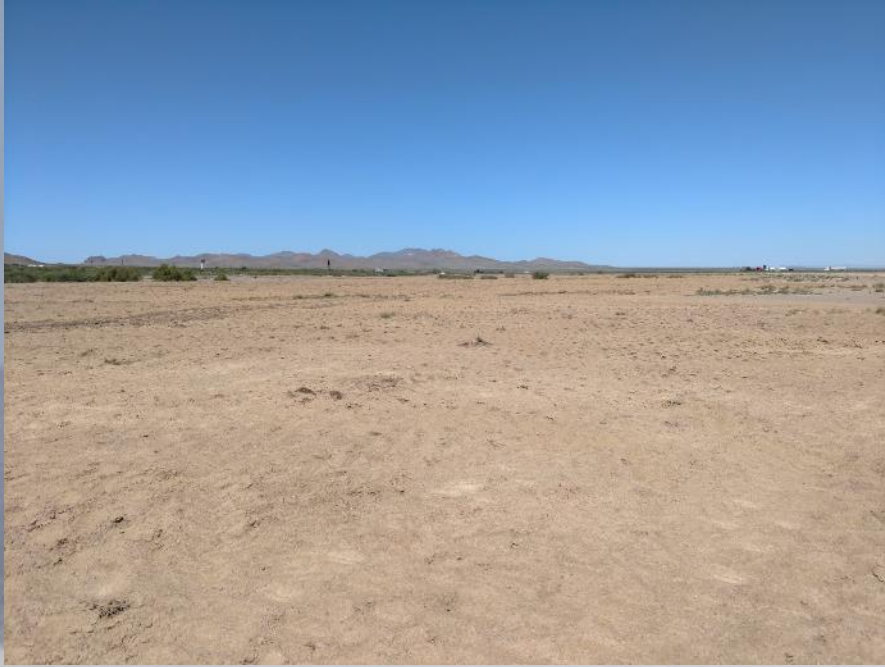
Revegetation Area

Road Forks Dust Mitigation Area September 2018

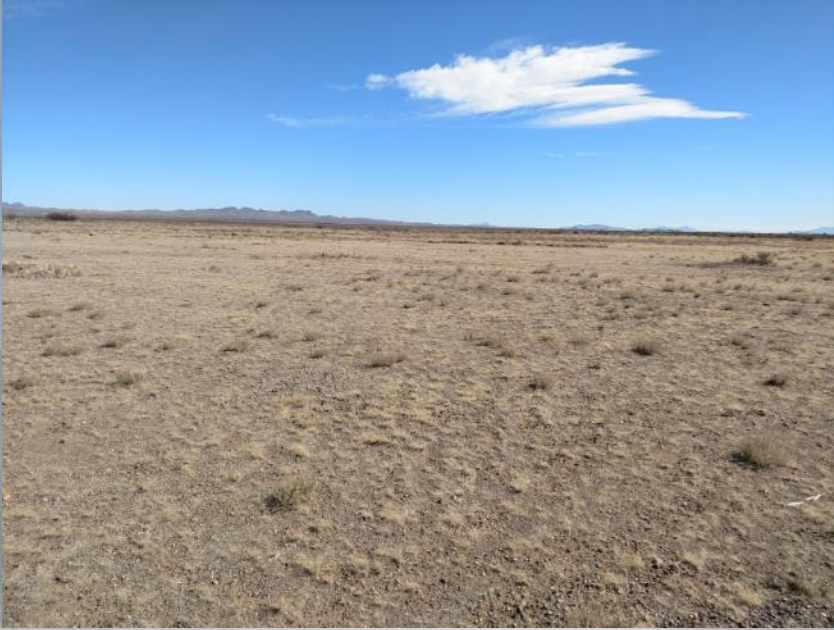
Revegetation Area

Road Forks Dust Mitigation Area

February 2021

- Revegetation is primarily non -native species from relic seed bank
- Recovery hindered by multi -year drought

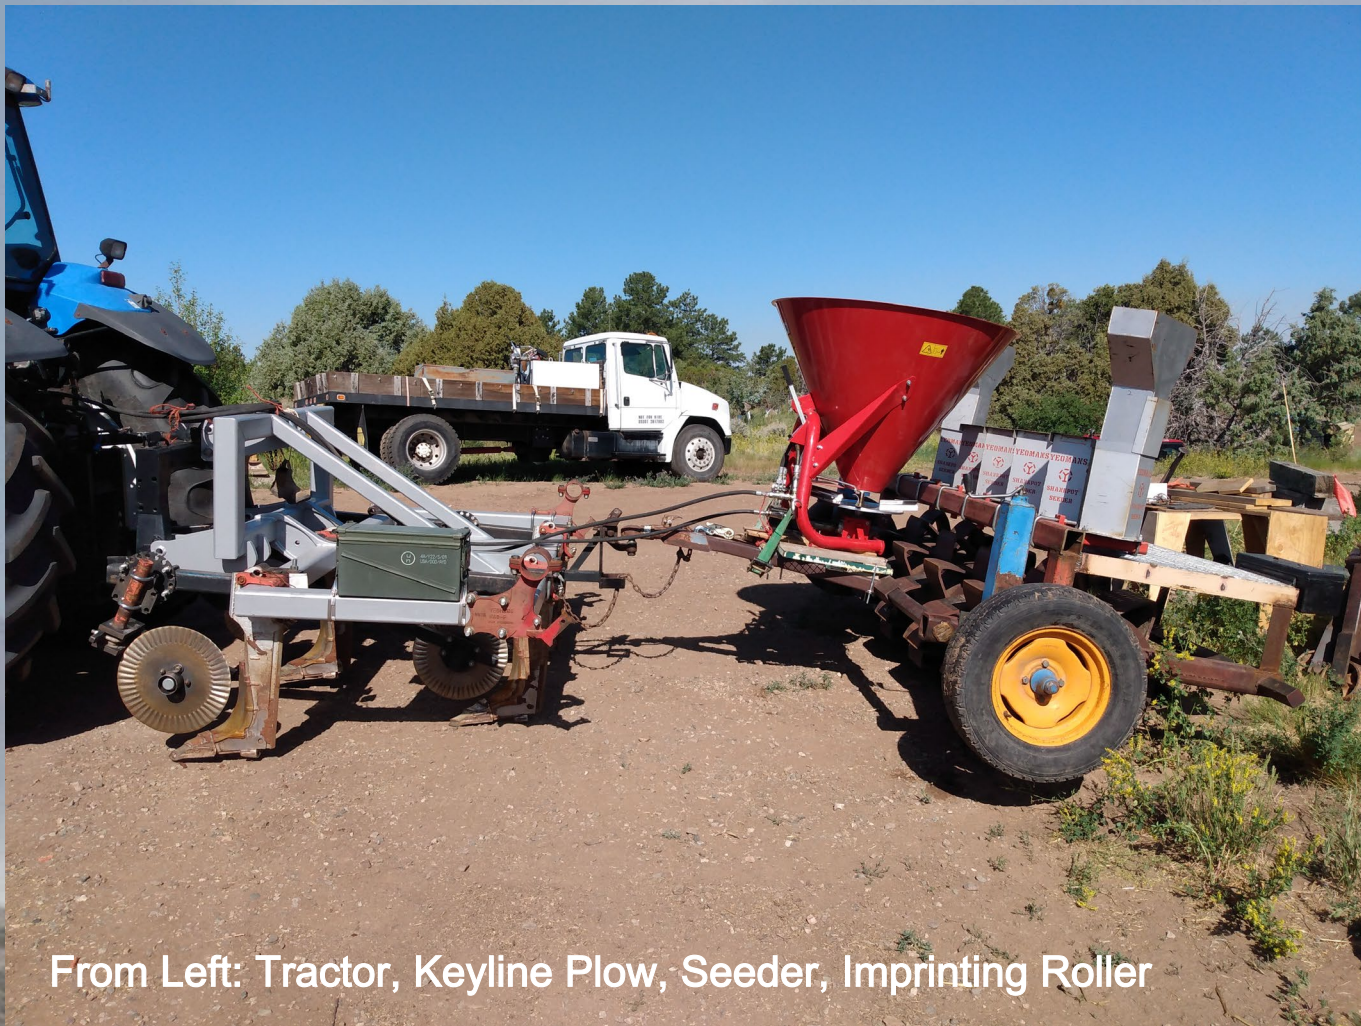
From Left: Tractor, Keyline Plow, Seeder, Imprinting Roller

1. Revegetation: Keyline plowing, imprinting, native seeding
2. Erosion Control: Stabilization of channels, banks, & degraded ranch infrastructure
3. Land use management adaptation

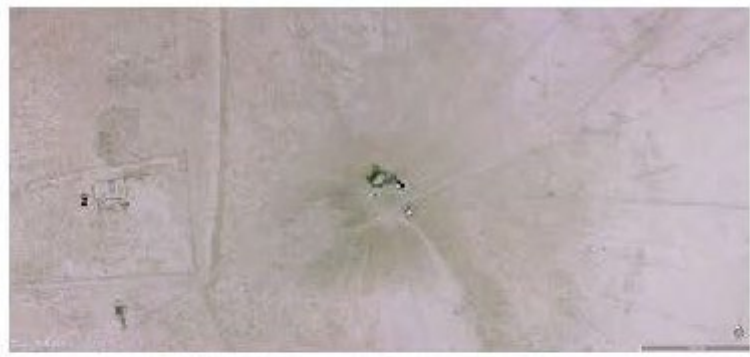
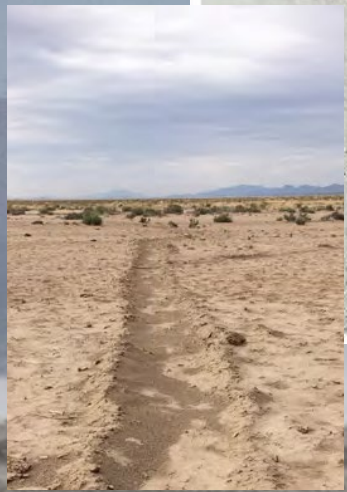
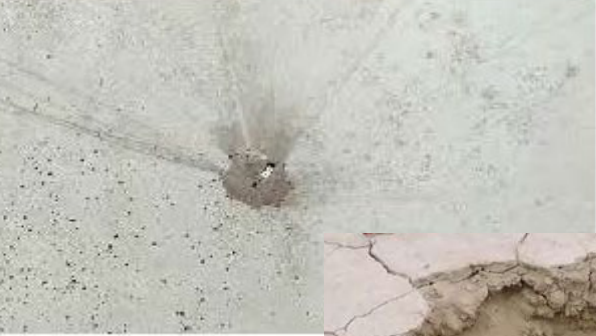
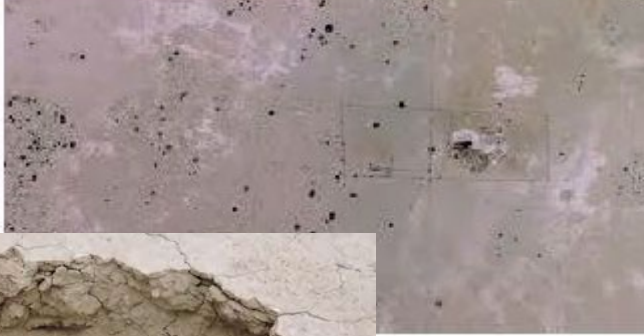
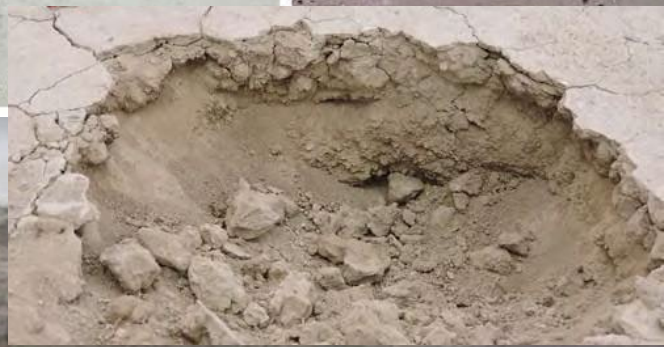
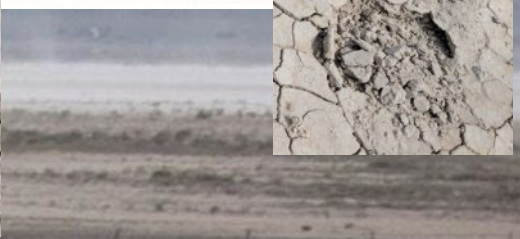
Playa & Playa Steppe Surface Disturbance

Erosion Control
