Lordsburg Playa Watershed Restoration to Reduce the Severity of Dust Storms on I-10

Trent Botkin & Bill Hutchinson

Updated May 2024

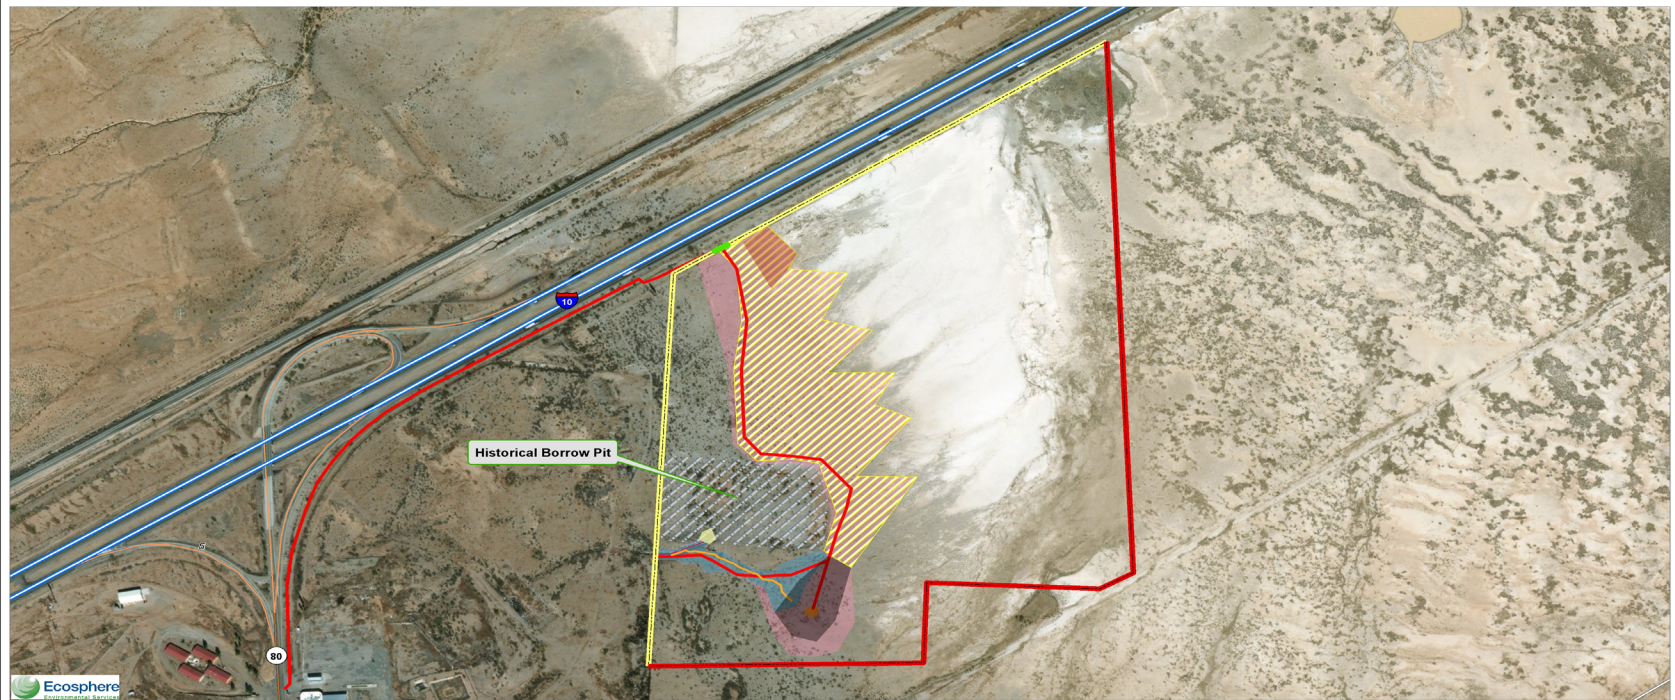
Road Forks Dust Mitigation Area Final Design

| — Access Road | — Trash Removal Area | — Rock Staging Area | — Microbism Concentration |
| — Existing Fence | — Historical Channel | — Media Luna Impact Area | — Imprinting and Seeding |
| — Access Gate | — Headcutting Arroyo | — Imprinting, Seeding, and Tackifier Application Area | |
| — Proposed Fence | — Channel Work | | |

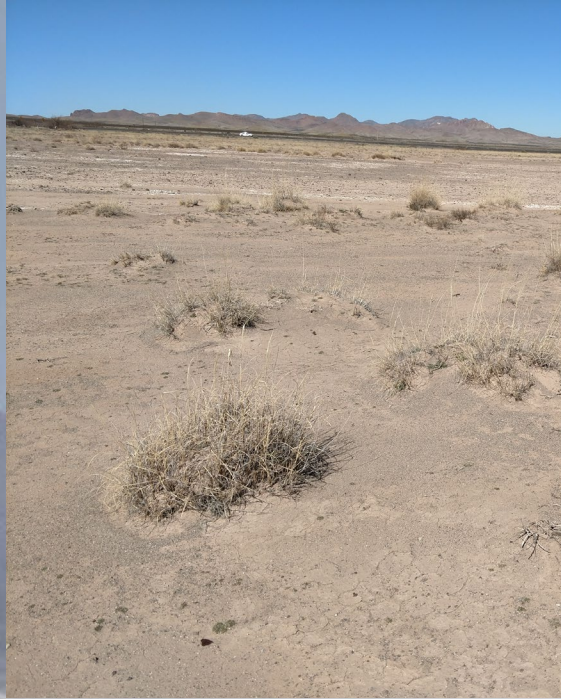
Revegetation Area

February 2019 (**5 months** after Implementation)

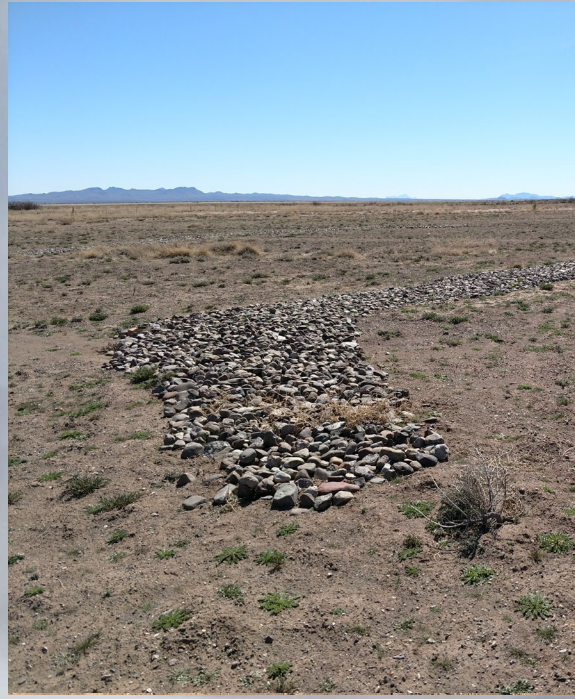
**Channel Restoration
Area**

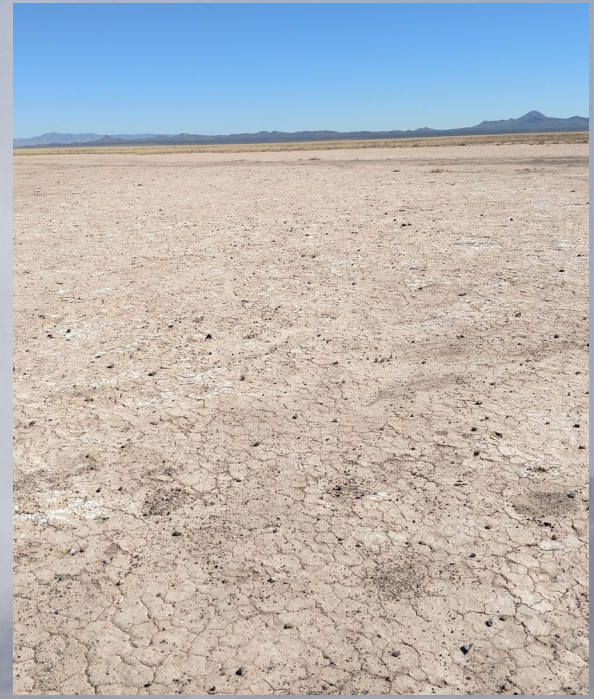
**Crust Re-Establishment
From Grazing Exclusion**

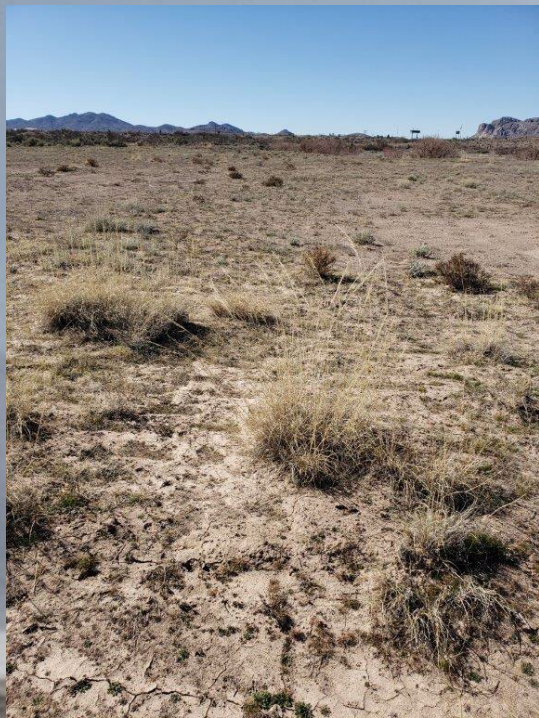
Revegetation Area

January 2019 (**16 months** after Implementation)

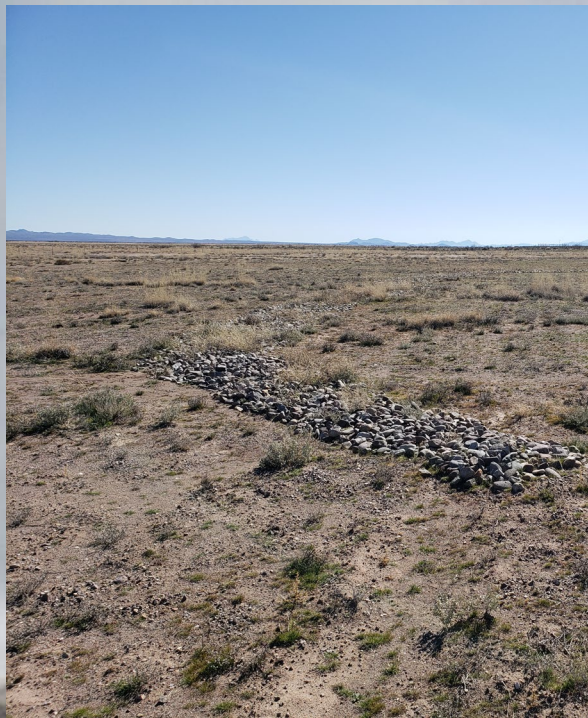
**Channel Restoration
Area**

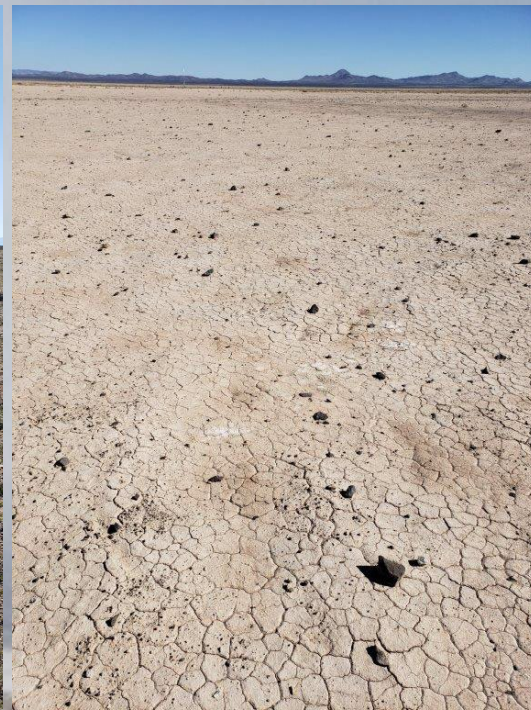
**Crust Re-Establishment
From Grazing Exclusion**

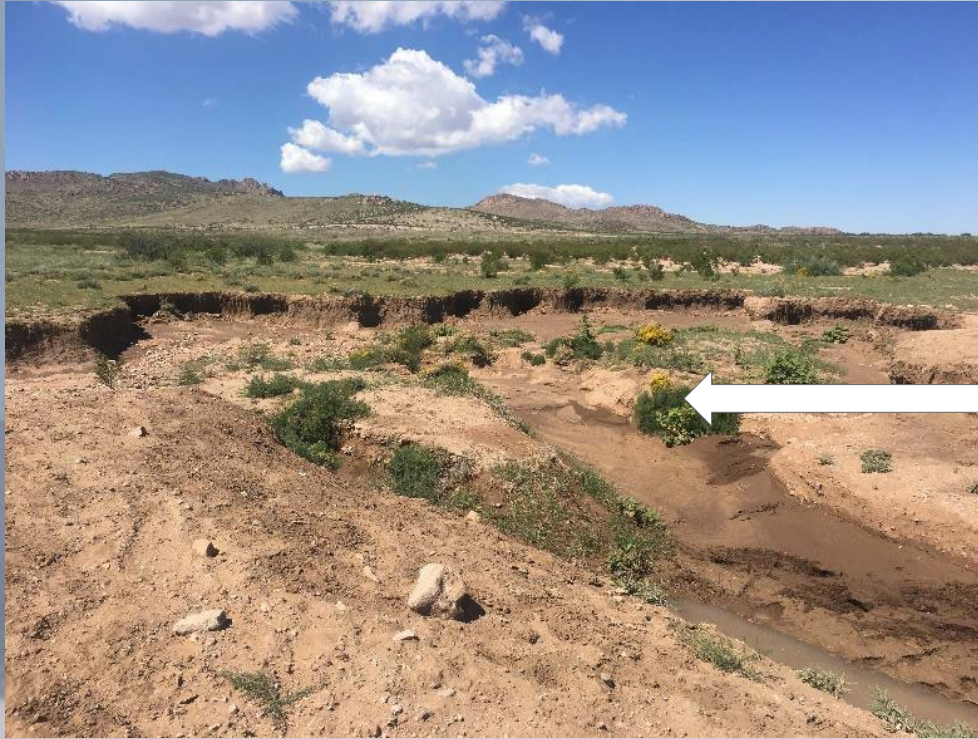
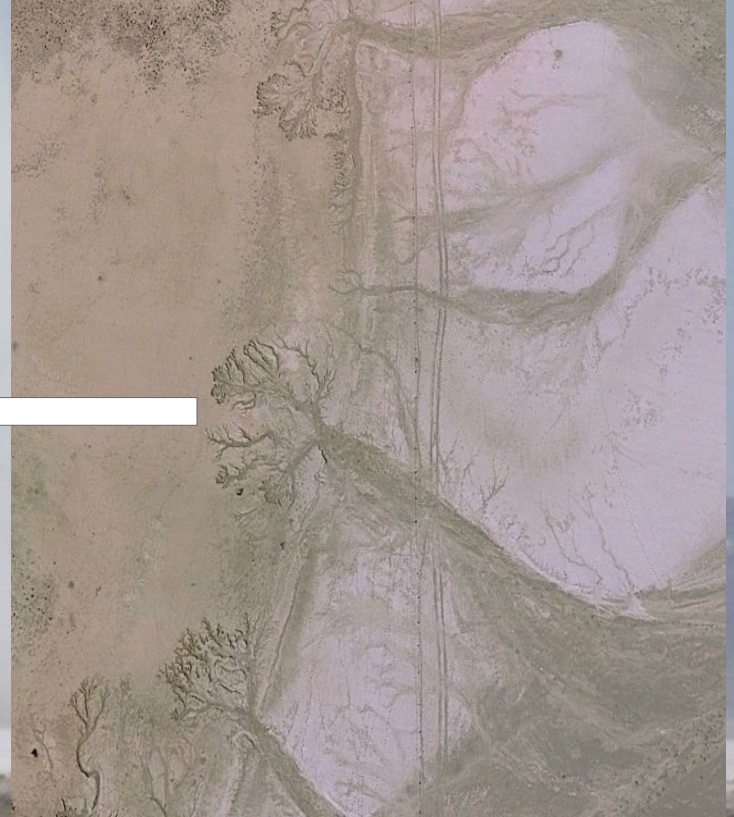
Breached Berm Causing Grassland Erosion and Depositing Sediment on Playa

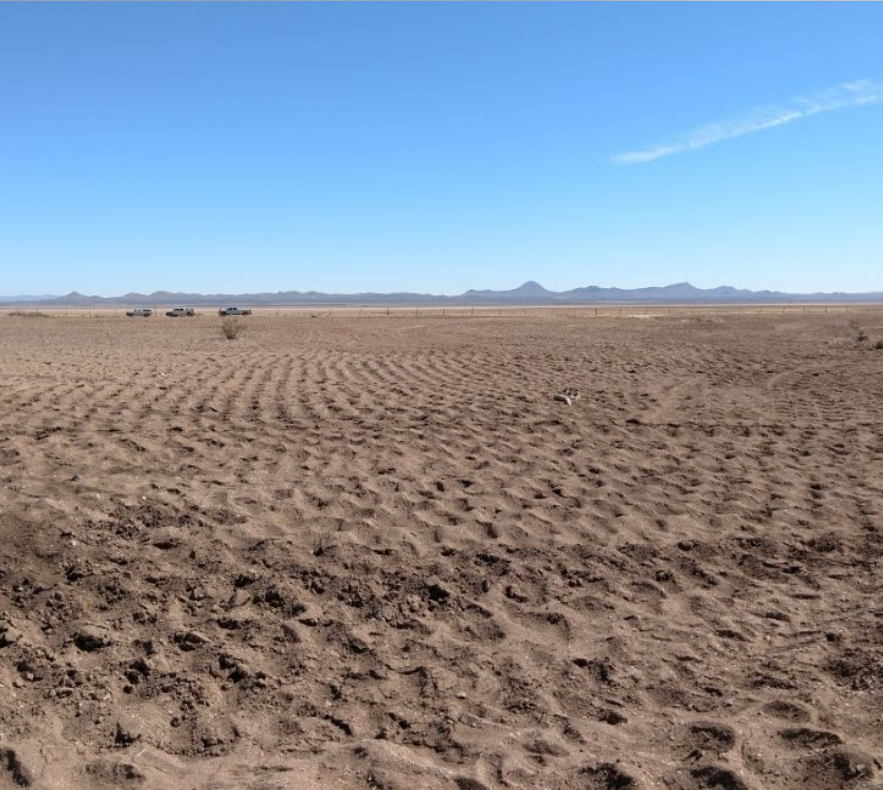
Keyline, Imprint & Seeding on Degraded Grassland

December 2020

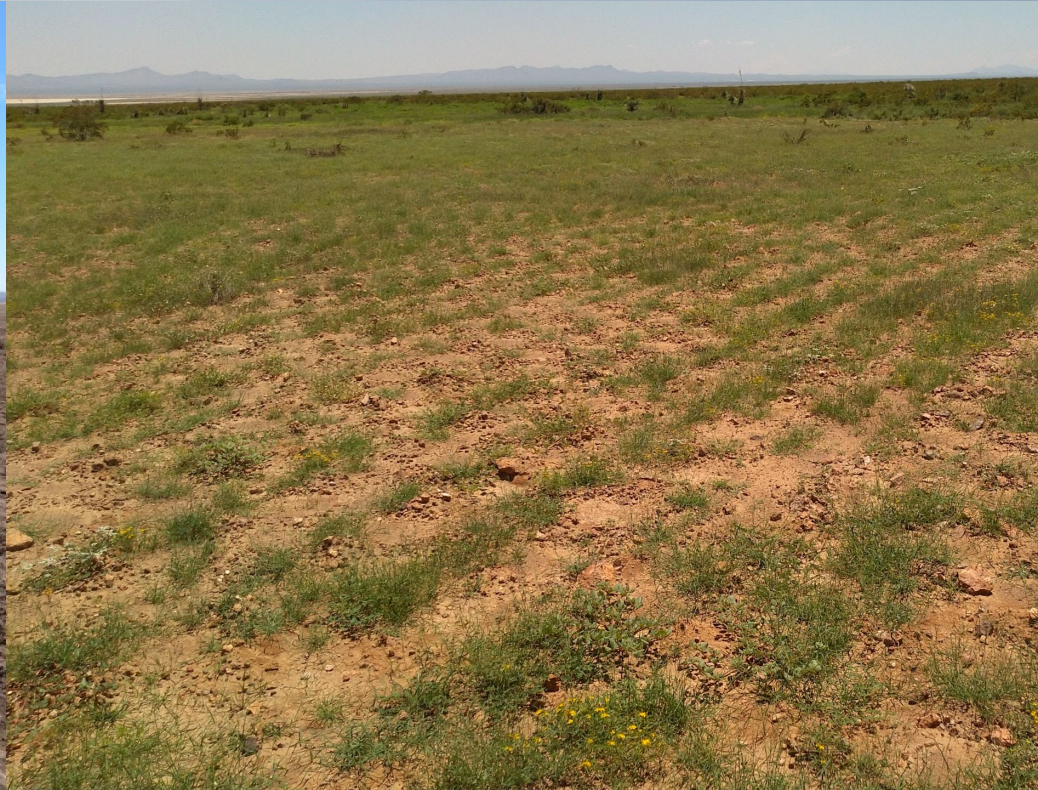
July 2021

Keyline, Imprint & Seeding Around Erosion Headcut

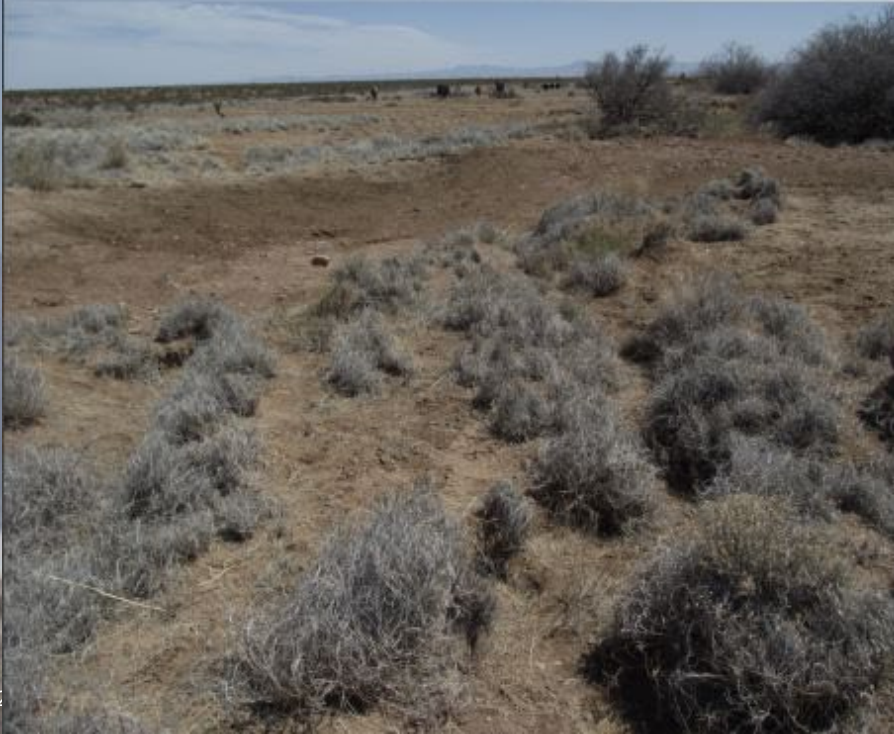
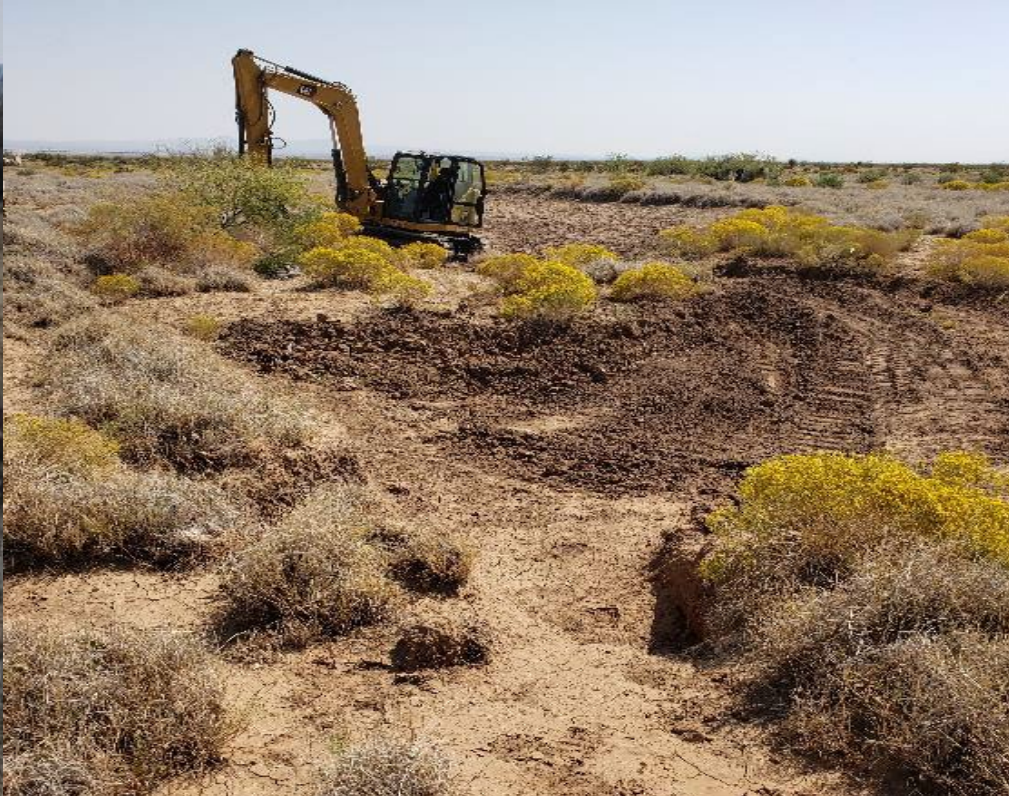
1-Rock Dams Stop Downcutting, Restores Sheet Flow & Infiltration

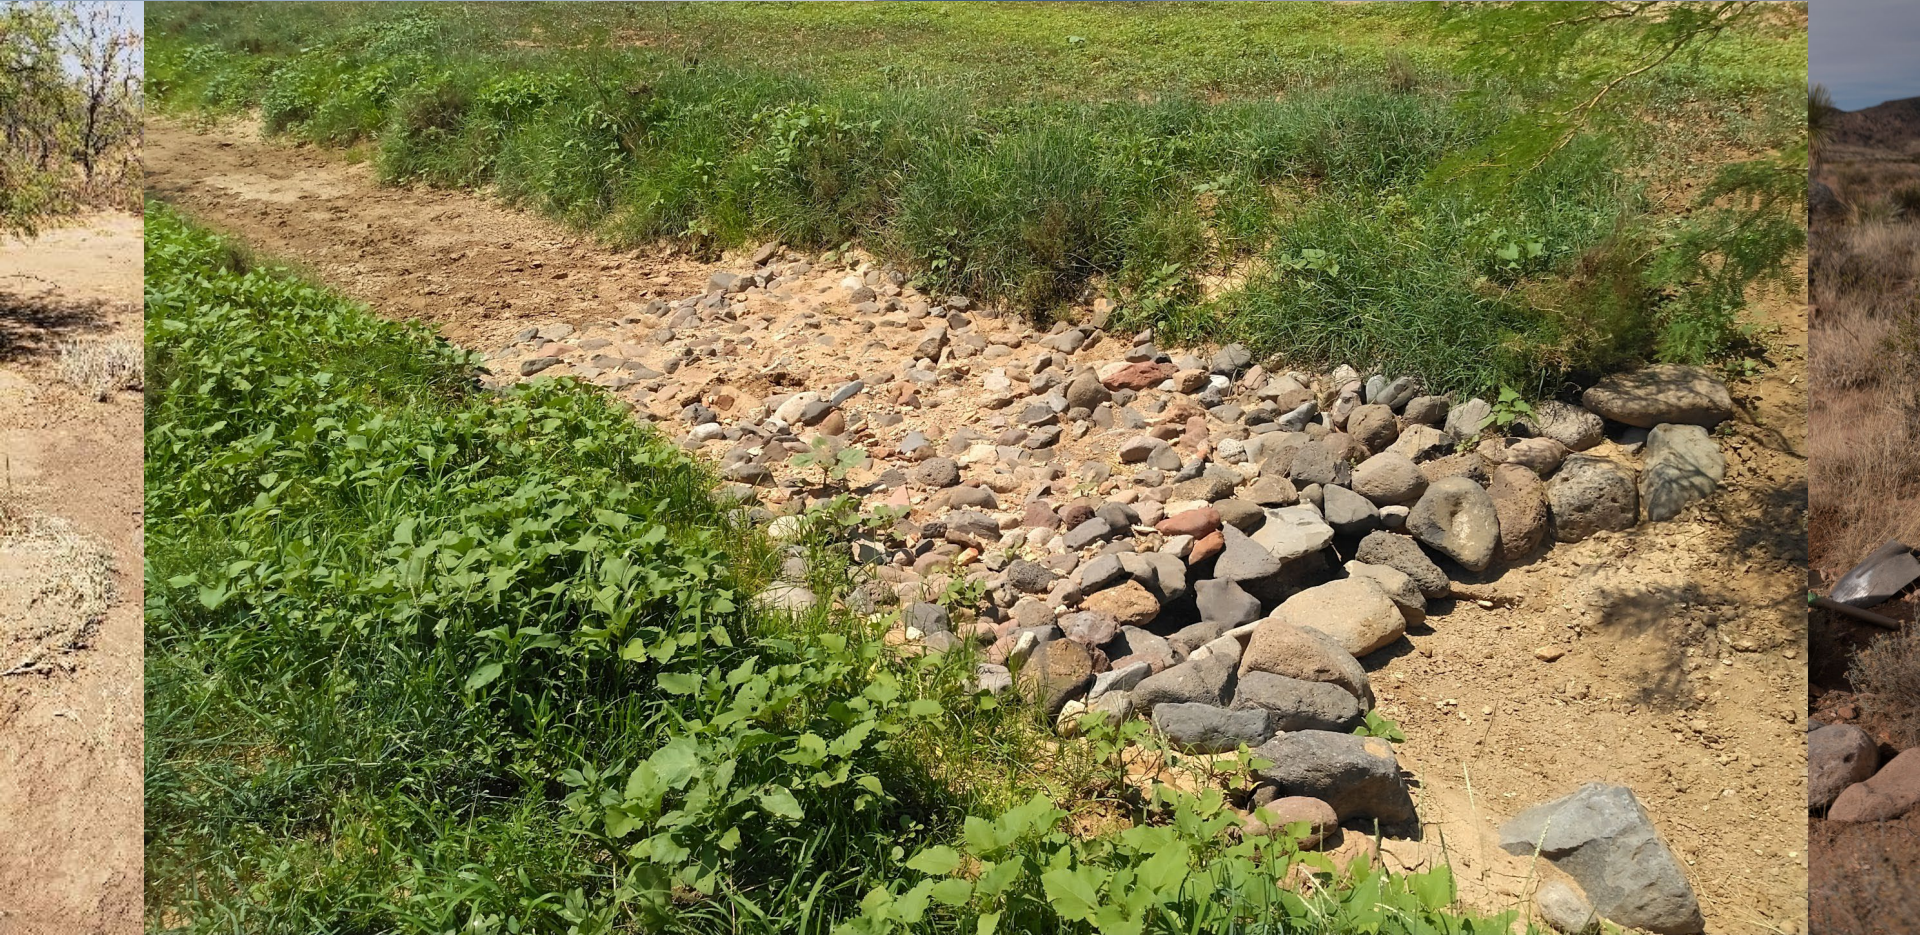
Cattle Disturbance on Playa Surface
